Test Report

Report No. WT NET 13-20

Name of Product: Warning Yellow Nylon Elevator Pulleys
Model of Produce: $\phi 210$, $\phi 240$, $\phi 320$, $\phi 360$, $\phi 400$, $\phi 440$, $\phi 480$,
 $\phi 500$, $\phi 520$, $\phi 540$, $\phi 560$, $\phi 640$
Client: Yangzhou Saierdanilong Manufacture Co., Ltd
Manufacturer: Yangzhou Saierdanilong Manufacture Co., Ltd
Category of test Entrust

National Elevator Inspection and Testing Center

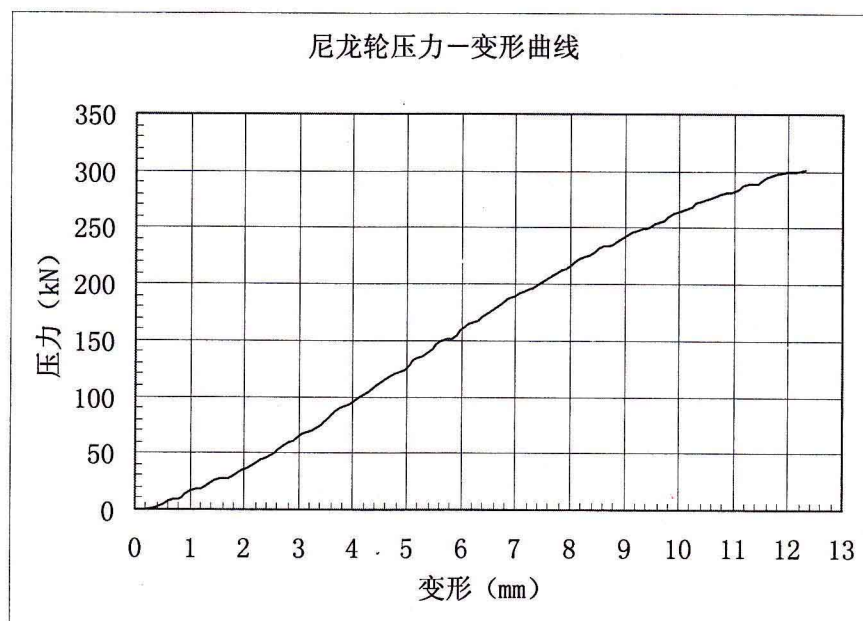
Figure 1 pressure-deformation curve of nylon pulley

| No. | Nylon pulley | | | Cast iron pulley | | |
| 10 | 301.8 | 12.29 | No | / | / | / |

- Note: 1. Deformation in above table means that the diameter of the sample gets smaller with pressure.
2. Tested after 24 hours of the ending pressure test, remaining deformation of the nylon pulley is 1.5mm.

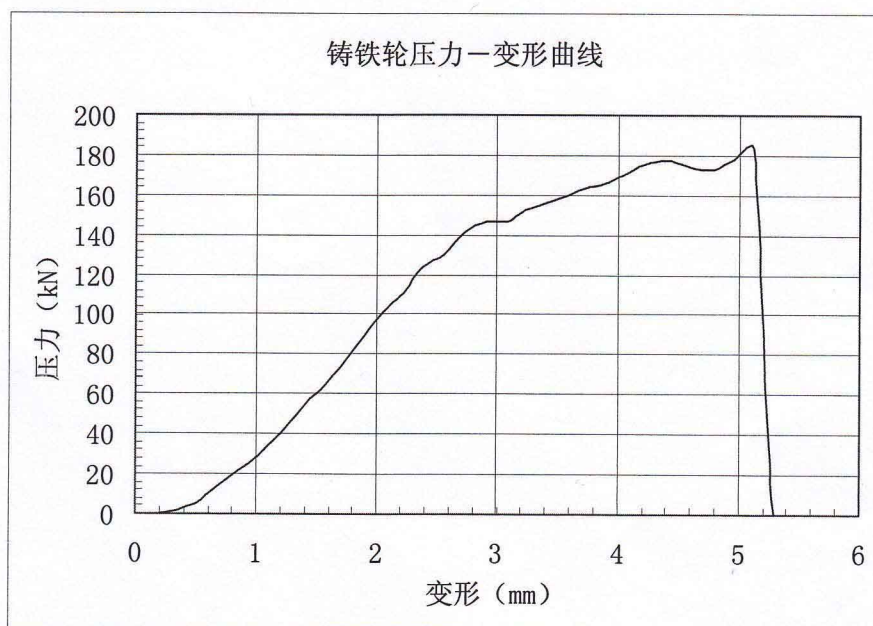
Figure 2 pressure-deformation curve of cast iron pulley

| No. | Nylon pulley | | | Cast iron pulley | | |
|---|---|---|---|---|---|---|
| 6 | 180.3 | 6.66 | No | 183.0 | 5.12 | Broken |

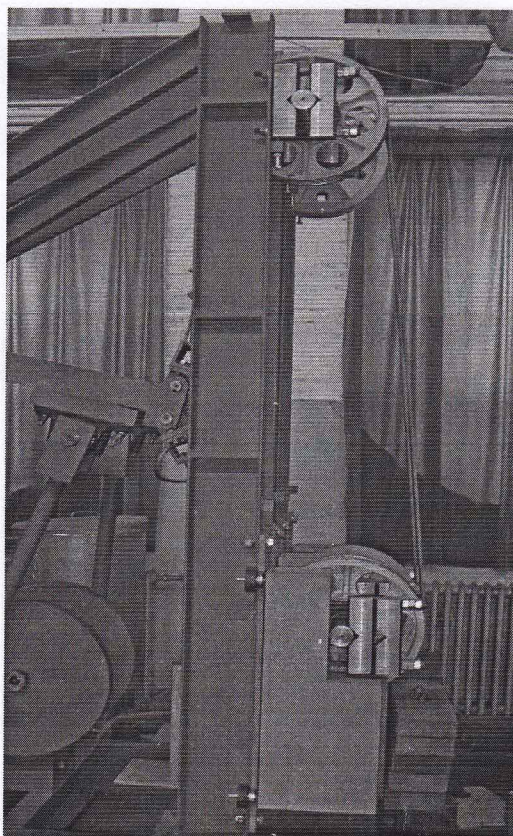
Figure 3 Installation of abrasion test

Two testing nylon pulleys are installed top and lower, a looping rope around them and the test tensioning mass shall be suspended. The rope and the pulleys are installed on the rope fatigue testing machine. The testing machine has two separate sets. Either set can work independently at the same time. See Figure 3 for the installation. To compare with nylon pulleys, cast iron pulleys are tested at the same time. All installation and test conditions are all the same.

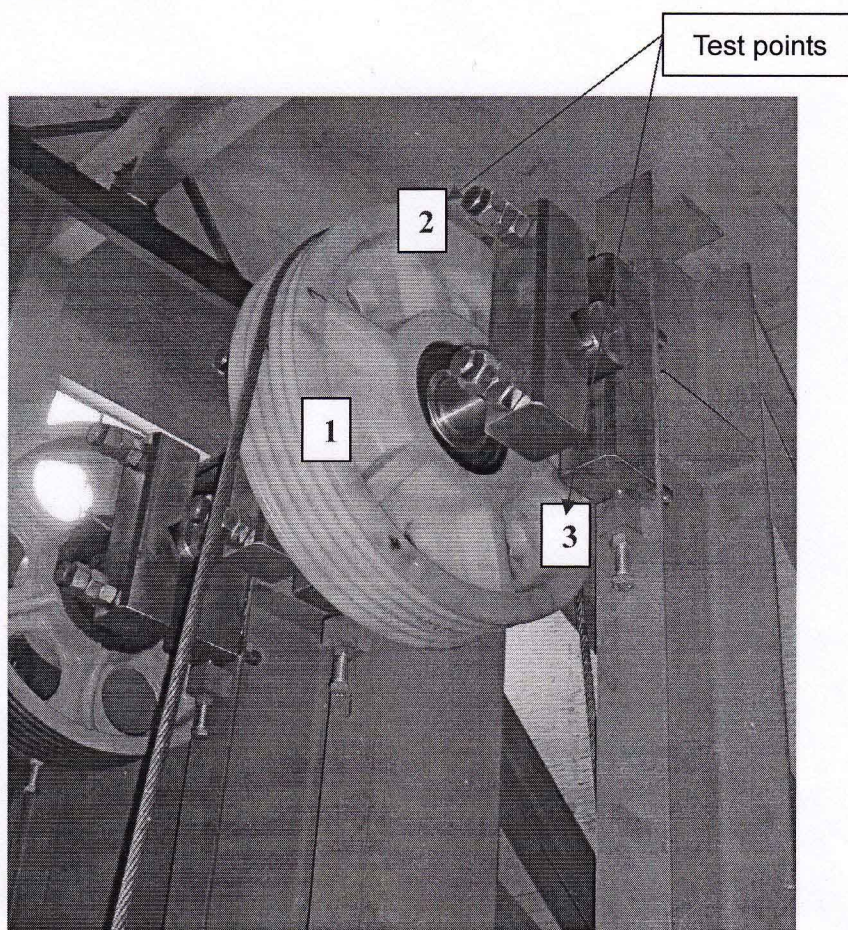
Figure 4 Test points of abrasion test

There are three test points on each pulley marked ①, ②, ③, showing in Figure 4. In a test cycle, test point ① contacts with wire rope in half cycle, test point ② contacts with wire rope in the whole cycle and test point ③ contacts with wire rope in one third of cycle.

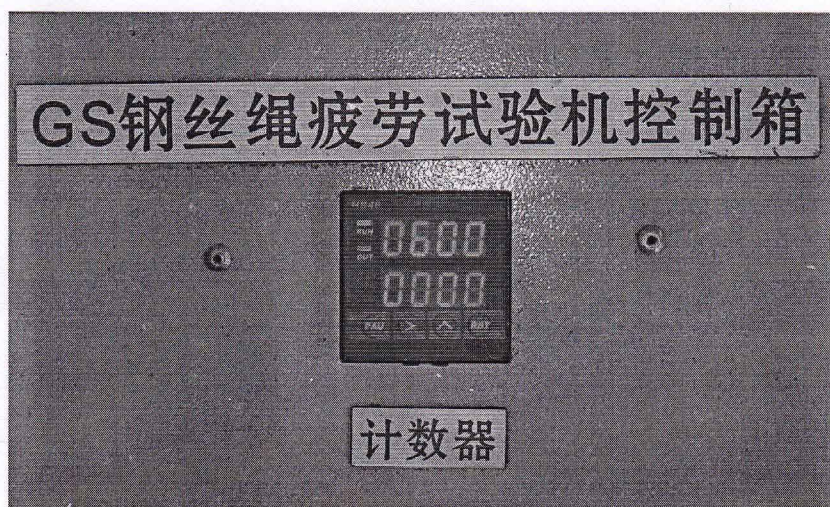
Figure 5 6×10^6 cycle showing on arithmometer ending 1562 hours abrasion test

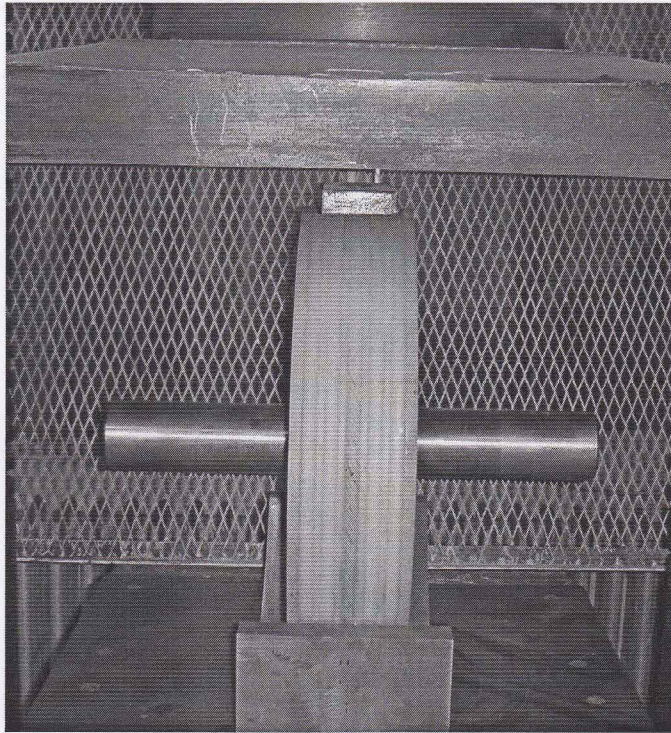
Figure 6 Installation of pressure test of nylon pulley

Pressure test is carried out after abrasion test. Installation and breakage are showing in Figure 6~8. Pressure test data is recorded in Table 3.

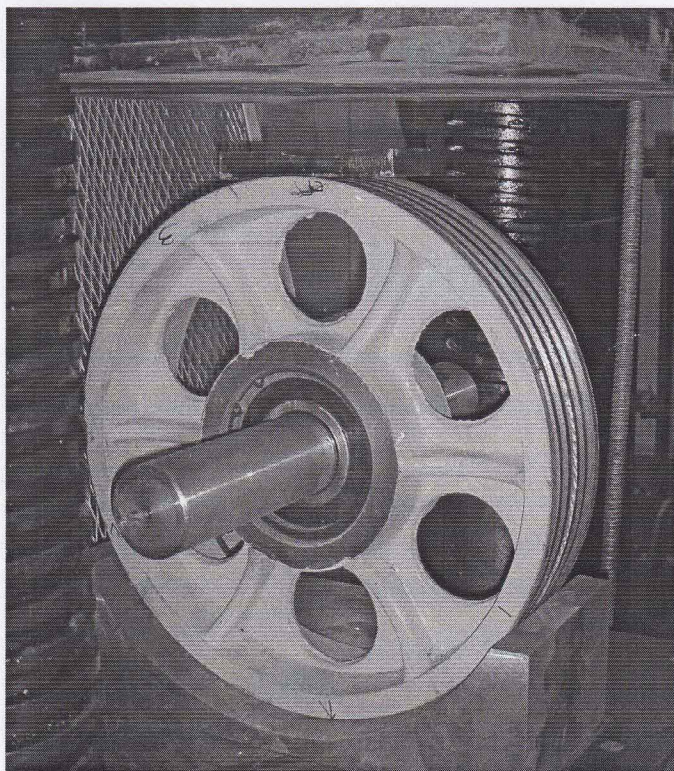
Figure 7 Installation of pressure test of cast iron pulley

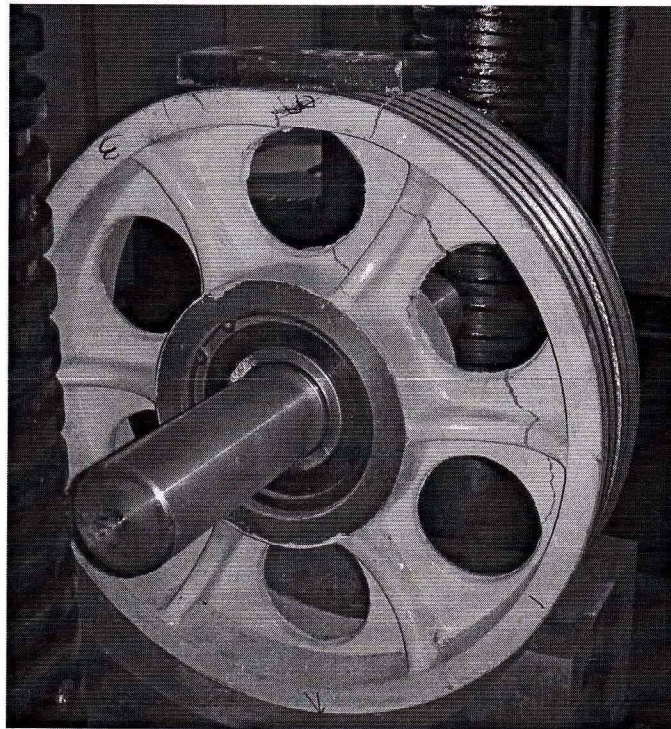
Figure 8 Broken in pressure test
